## Remediation Report

Date: April 24, 2009.

Premises: Miller Street, North Sydney.

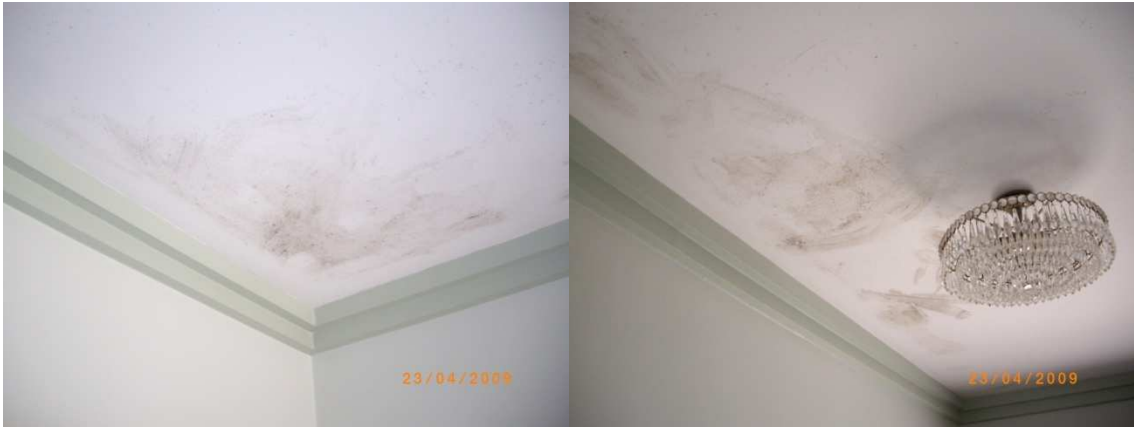
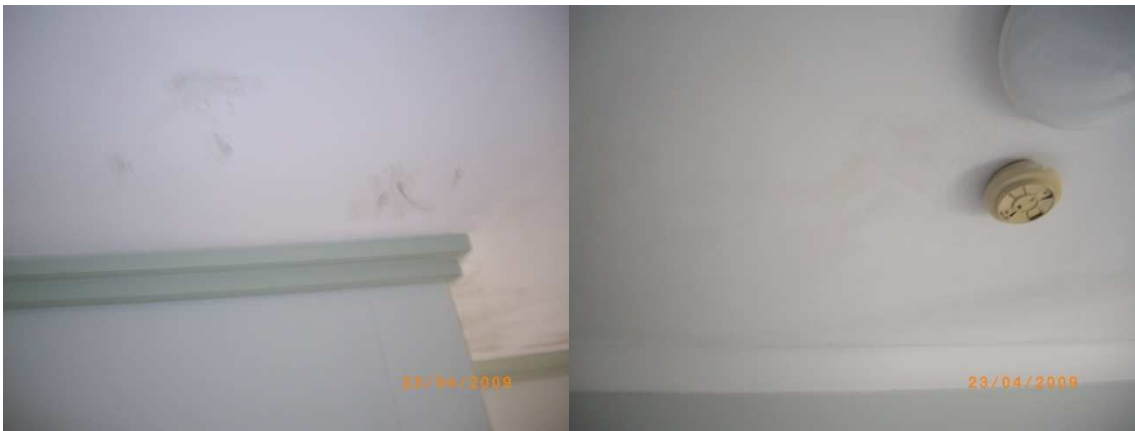
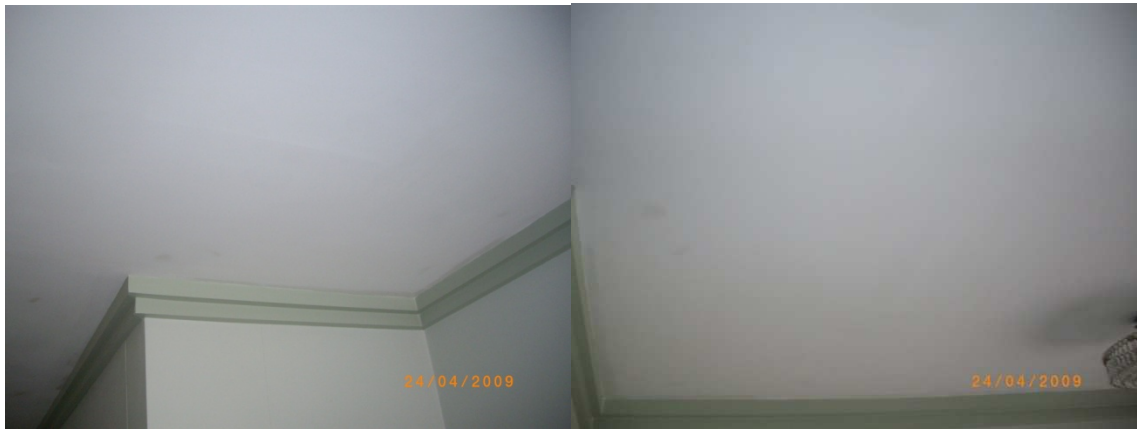
Job Details: Inspection of the building and apartment showed active mould growth on the ceilings within the kitchen area, lounge room, main and second bedrooms.

The mould that was present in apartment 43 is considered consistent with such an incident as the visible mould was confined to the ceiling only. Had Air Quality testing been done at this time, it is our opinion that mould spores would have been present at elevated levels.

*Miller Street, North Sydney. Enlargements of photos available upon request. Note that mould is restricted to the ceiling consistent with a our report.*

The areas of active mould growth were decontaminated and fogging was carried out to ensure the elimination of airborne mould spores. Carpet cleaning was also performed to further eliminate mould spores.

Recommendations: It is our recommendation that the floor of the room housing the water tank be correctly dried and sealed with adequate drainage or containment considered so as to prevent any further problems arising. We also recommend the installation of a fan in the kitchen area to circulate the air freely and a dehumidifier within the apartment to assist in eliminating moisture that may continue to leech through the concrete roof. Annual inspection of this unit is also recommended with any future active mould growth being remediated should this is required.
