The Paramount Shopping Centre

Melbourne Australia

These figures are based upon hard wiring of an energy usage monitor to a single HVAC unit and are for a period of 4 days prior to cleaning of the unit and 4 days post cleaning.

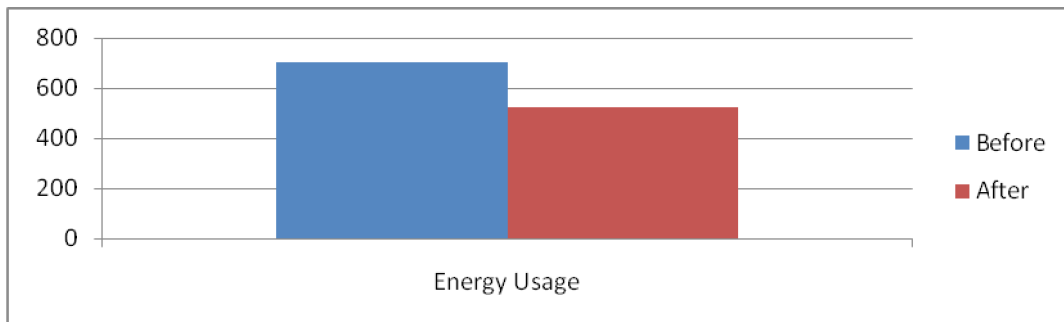
1 day prior	67.103	1 day after	58.068
2 days prior	251.917	2 days after	105.998
3 days prior	240.655	3 days after	178.766
4 days prior	142.053	4 days after	179.237
	701.728		522.069

These figures consistently show a saving of >25%

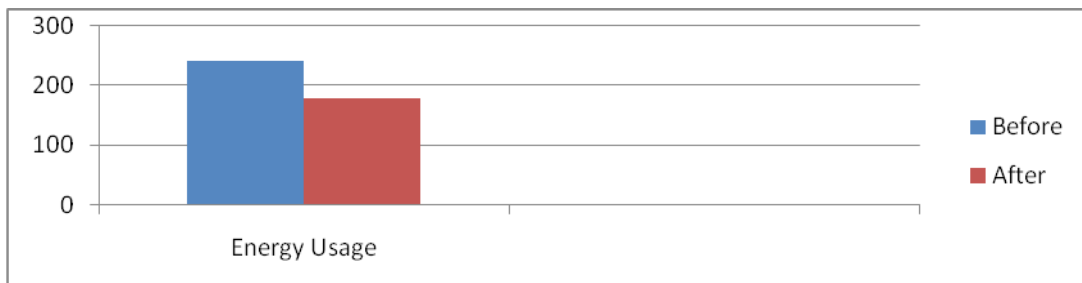
Validation of figures

Wednesday before **240.655** Wednesday after **179.237**
